Service Bulletin

Category S	Applicable Model/s 1988-'91 626/MX-6	Subject WIND NOISE	Bulletin No. 036/92 Issued 7/7/92 Revised
---------------	--	---------------------------	---

DESCRIPTION

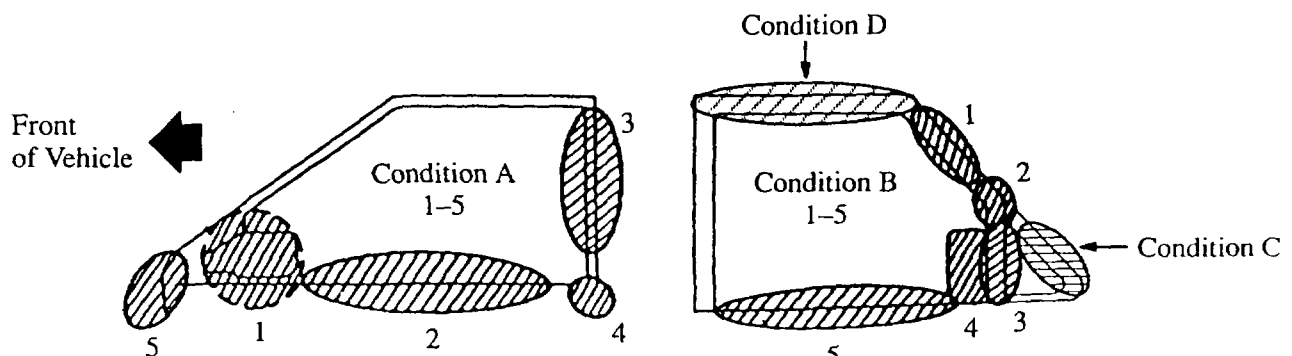
The illustration below shows the general areas where wind noise may occur (A-D). Specific locations of wind noise are shown numerically.

- A) Wind noise at front door area during high speed (above 40 mph) driving (pages 2 through 7).
- B) Wind noise at rear door area (pages 8 through 11).
- C) Wind noise/fluttering noise at rear corner window area (pages 11 and 12).
- D) Wind noise from front and rear door area due to window drop (page 13).

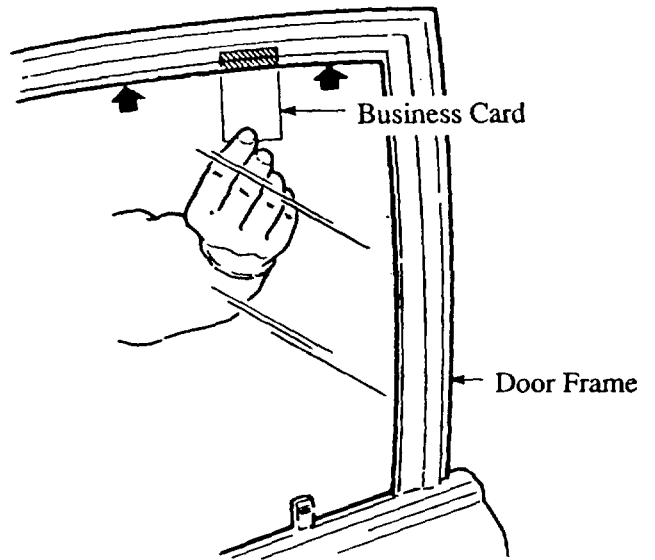
1. Use a business card as you would a feeler gauge to check for looseness (gaps) between the door glass and weatherstrip. The weatherstrip should press firmly against the glass around the entire door frame. Areas that do not form a tight seal between the glass and weatherstrip may allow the glass to drop thereby causing air leaks.
2. With the window in the down position, remove the following parts according to Workshop Manual procedures section S:
 - a) Black Plastic Inner Sail Garnish
 - b) Window Frame Weatherstrip
3. Remove the weatherstrip to access the glass run channel frame.
4. Carefully bend the weatherstrip frame slightly outward ($1/16''$) to increase the pressure of the weatherstrip against the glass. Use a sheet metal bending tool (Snap-on P/N VP8R or equivalent).
