# Service Bulletin

Category K	Applicable Model/s 1988-90 626/MX-6 incl. Turbo	Subject EC-AT SLIPPAGE IN FORWARD GEARS	Bulletin No. 005/90 Issued 5/14/90 Revised
---------------	---	--	--

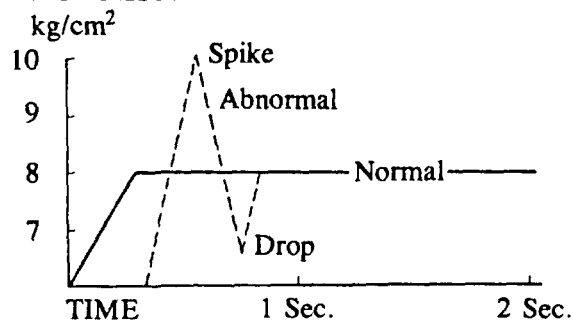
LINE PRESSURE

- A good oil pump should show a smooth increase of pressure and level off at a stable pressure.
    - If the spool valve of the oil pump is stuck, it may cause a pressure spike and variation in pressure before leveling off, or it may show little/no increase in pressure. (Refer to the illustrations.)

4. If a problem is found in Step 3, replace the oil pump spool valve according to the Replacement Procedure.
5. Recheck the line pressure according to Step 2 and perform the road test to confirm that the problem is fixed.
