Service Bulletin

Category K	Applicable Model/s See below	Subject ATX MANUAL SHAFT LOCK NUT TORQUE	Bulletin No. 004/90
			Issued 4/23/90
			Revised

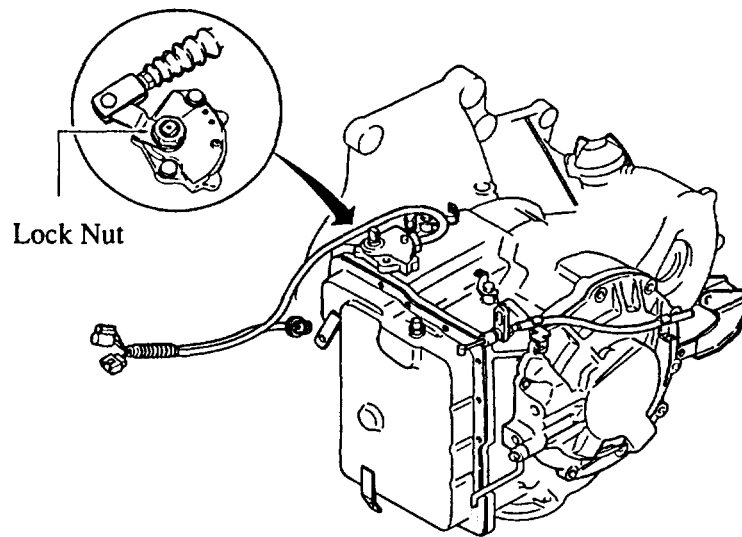
When tightening the manual shaft lock nut of the automatic transaxle, be sure to tighten it with the specified torque listed below.

The use of a powerwrench (air or electric impact wrench) is **not recommended** when installing the lock nut. Reaction force applied to the shaft during installation may cause internal transaxle damage.

TIGHTENING TORQUE

1986-90 626	44-64 N-m (33-47 ft-lb, 4.5-6.5 kg-cm)
1988-89 323	44-64 N-m (33-47 ft-lb, 4.5-6.5 kg-cm)
1990 323/Protegé	31-46 N-m (23-34 ft-lb, 3.2-4.7 kg-cm)
