Service Bulletin

Category 7	Applicable Model/s 1988-89 626/MX-6 & 929	Subject TURBINE SENSOR/PULSE GENERATOR	Bulletin No. 067/89 Issued 10/12/89 Revised
---------------	---	---	---

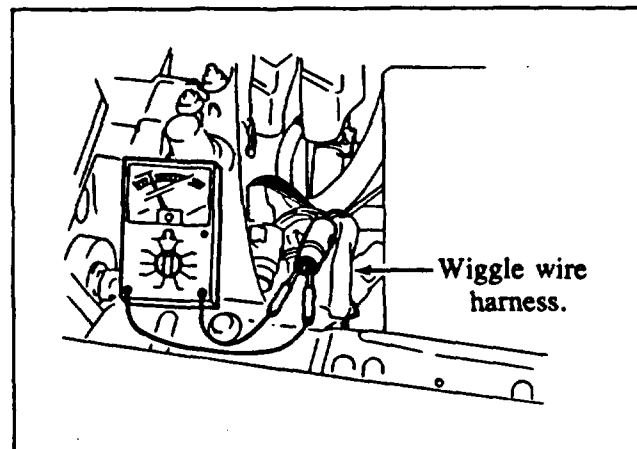
On some of the subject vehicles, the hold lamp goes ON and OFF while driving. If the EC-AT tester is connected, it indicates "Code 55". As one of the causes for this phenomenon, poor internal contact of the turbine sensor is probable.

When judging the performance of the turbine sensor, wiggle the wire harness of the turbine sensor as illustrated below and check whether the resistance value is within the specification.

If a poor contact exists in the turbine sensor, resistance value changes and the value reads out of specification when wiggling the wire harness.

Model	Resistance Specification
626/MX-6	200-400 Ω
929	Approx. 245 Ω
