# Service Bulletin

Category S	Applicable Model/s 1988-91 626/MX-6 (USA Made)	Subject  WATER ENTERING INTERIOR	Bulletin No. 006/93 Issued 2/12/93 Revised
---------------	--	--	--

Some 1988-91, USA made 626/MX-6 vehicles may experience interior water leaks. This occurs in the front floor, the headliner (sunroof), or the trunk areas. If the area where water entered the vehicle cannot be confirmed, a water leak test must be performed. These tests are described in the Inspection and Repair section of this bulletin.

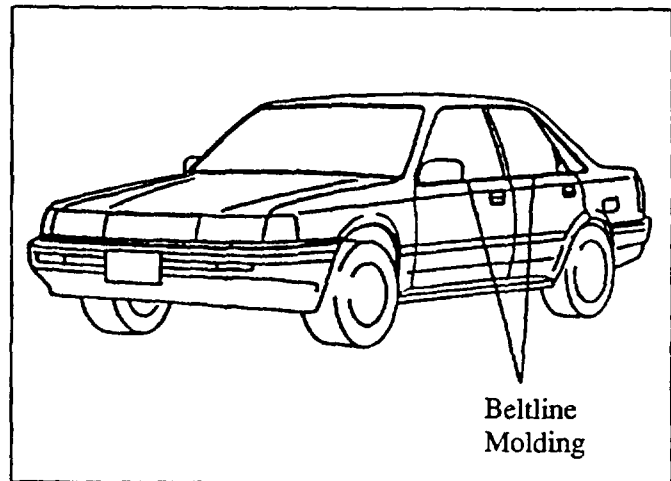
**Figure 1: Beltline Molding Location**

5. With the door closed, watch for water leaks during hose test. Have an assistant slowly direct the water stream up from the bottom portion of the door-to-fender seam, then up the "A" pillar to the top of the door and around the windshield. Next, have the assistant slowly direct water along the window beltline molding (if the vehicle is a four door, perform this test on both the front and rear doors.) **Figures 1 and 2.**

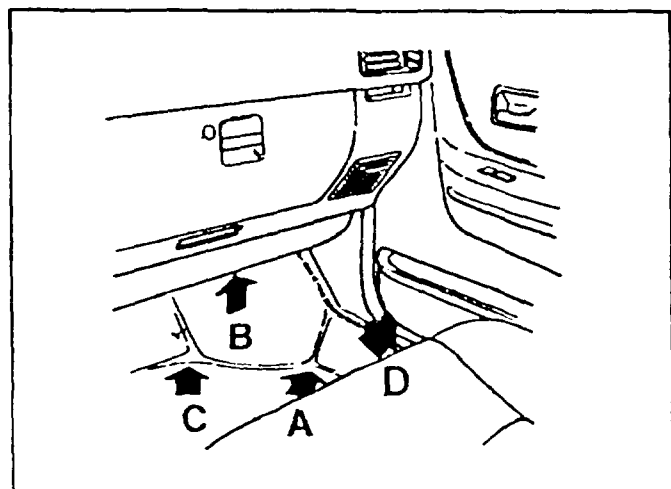
**Figure 3: Possible Water Leak Areas**

6. Note which area the water enters the vehicle. Refer to the appropriate location's repair procedure. **Figure 3.**

AREA A: KICK PANEL (pages 3 and 4)  
AREA B: UNDER DASH (pages 4 and 5)  
AREA C: CORNER OF FIREWALL  
AND INNER FENDER (page 5)  
AREA D: OVER SILL PLATE (page 6)

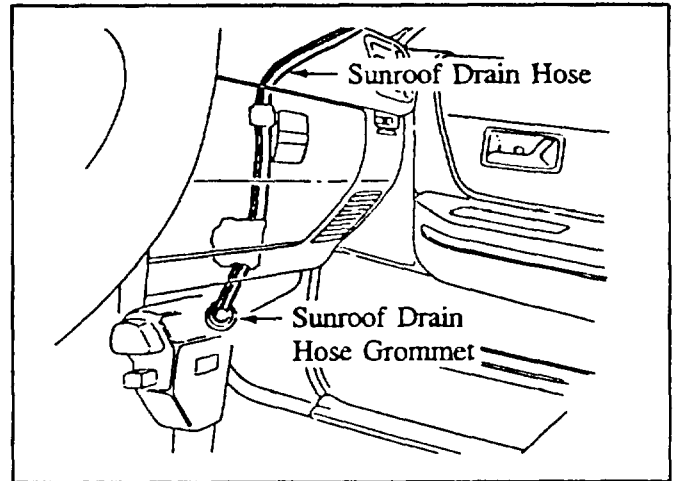
**Figure 4: Checking the Sunroof Drain Hose**

1. Remove kick panel and inspect.
2. Make sure that the door electrical harness boot and the sunroof drain hose grommet are seated. Check that the sunroof drain hose is not kinked and extends through the lower kick panel.

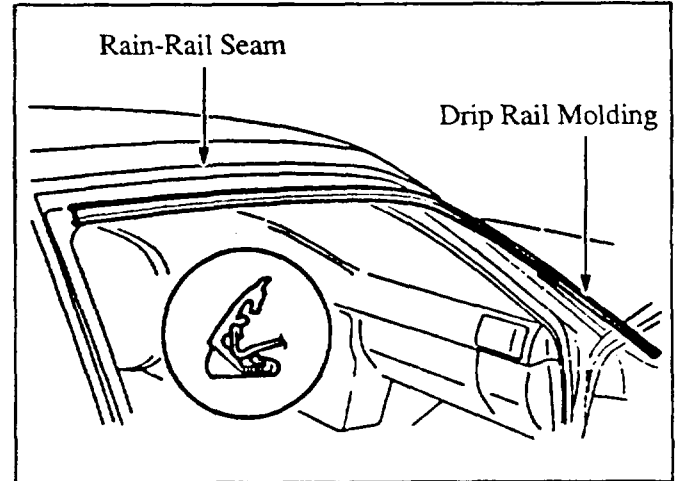
**Figure 5: Drip Rail Molding**

3. Remove the drip-rail molding and inspect rain-rail seams for missing sealer or pinholes. Seal any suspected sealer defects. **Figure 5.**
4. Open the sunroof. Using a squeeze bottle filled with water, pour water down the front drain holes. Check for signs of leakage at the sunroof drain tube-to-drain hose.

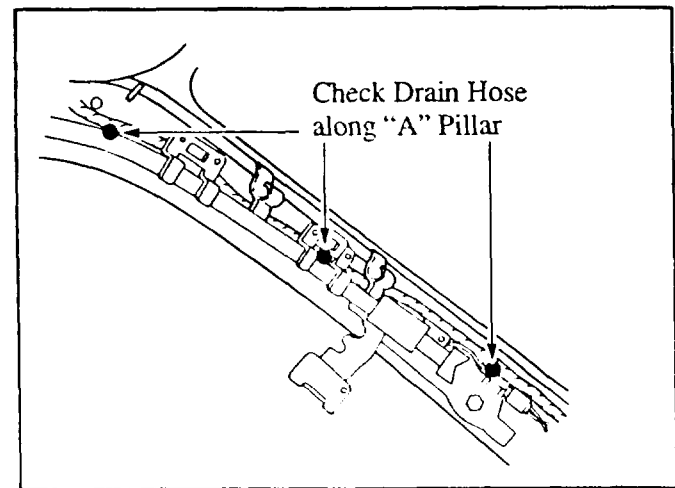
**Figure 6: Checking Front Drain Hose**

5. If the leak is still present, remove cap and screw from the front windshield header. Remove the "A" pillar side molding. Check the drain hose for kinks. **Figure 6.**
6. If necessary, reposition the hose so that there are no loops, kinks or pinched areas. Repeat the water test. Make sure that the sunroof drains properly with no leaks. **Figure 7.**

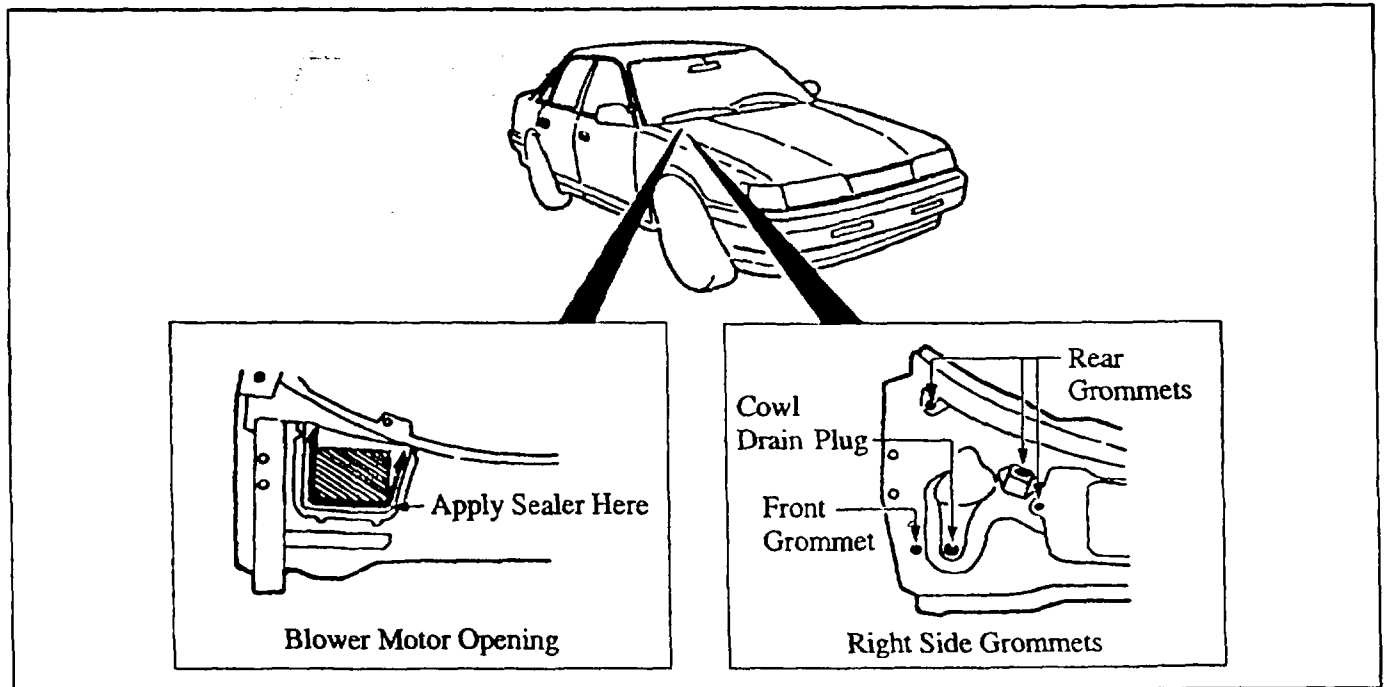
**Figure 8: Checking Right Side Cowl for Leaks**

1. Confirm that the upper cowl drain plug (black tube) has been modified (the dimension of the drain hole has been enlarged to 10mm). Also confirm that there are no obstructions and that the plug drains properly.
2. Using a mechanic's mirror, look for signs of water leakage under the dash (e.g. water/washer solvent stains).
3. Set the heater control air intake control lever to the first position. Remove the blower fan (3 screws) and look for water entering the blower motor opening.
4. Check all grommets shown in **Figure 8** for leaks by spraying water on each one. Replace any grommets that leak.

5. If the grommets do not leak, seal the baffle seam by reaching up through the blower motor opening and seal the areas indicated in **Figure 8**.
6. If water is leaking from the the firewall, check for studs and grommets that might be loose or improperly seated on the engine side of the firewall. If necessary, remove, redress, and reinstall the studs. Retap the holes and, if necessary, replace the bolts. Apply sealer to the threads before installing the bolts. Apply silicone sealer to the bottom of the grommets prior to installation.

**NOTE:** Apply silicone sealer to the bottom of the grommet during installation.

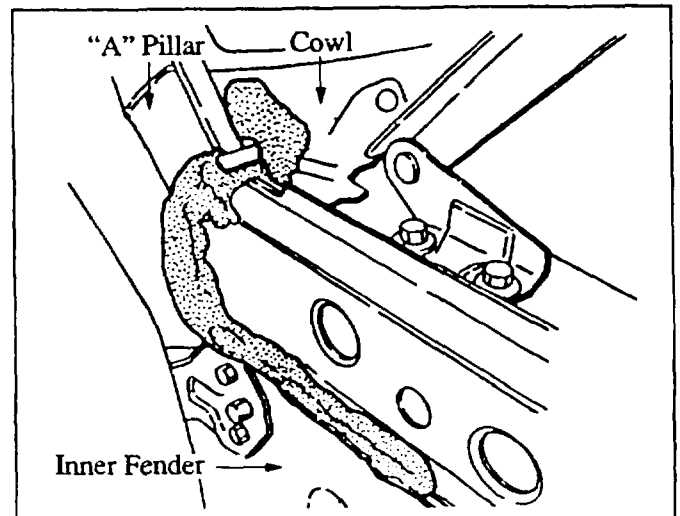
**Figure 9: View of Adequate Body Sealer**

1. Lift carpet and pad, and feel for water. If water is present, remove windshield wipers and cowl plate. Check for missing sealer or holes among the lower "A" pillar-to-cowl seam. Apply sealer to any suspected areas. **Figure 9.**

2. Remove the door jamb nut and bolt, also remove the four (4) upper fender bolts. Using a mechanics mirror, inspect sealer hidden by the upper fender for skips and pinholes. **Figure 9.**

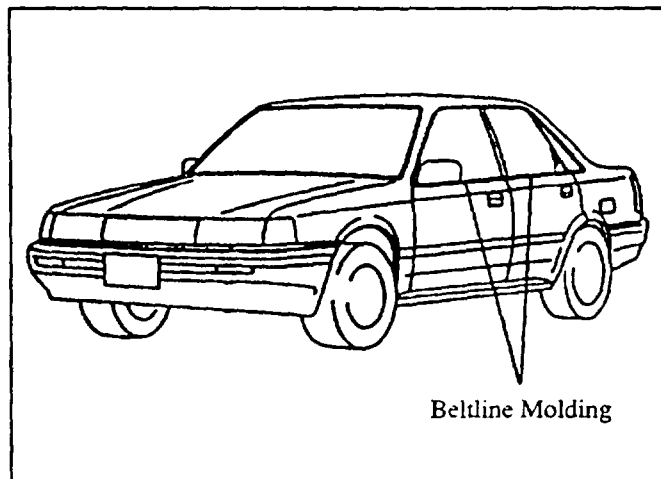
**Figure 10:** Area of Beltline Molding

1. While an assistant directs water along the beltline molding, inspect for water entering from over the plastic sill plate. **Figure 10.**
2. If water is entering over the sill plate, remove the door panel and check that the plastic sheeting Butyl sealer is pressed firmly against the door frame. Also, check that no gaps are present between the sheet metal and the plastic.
3. Confirm that the door drain holes are draining properly and are not obstructed.

**NOTE:** If Butyl sealer is hard or non-pliable, new sealer will need to be applied to the plastic sheeting to properly seal water leaking from these areas.

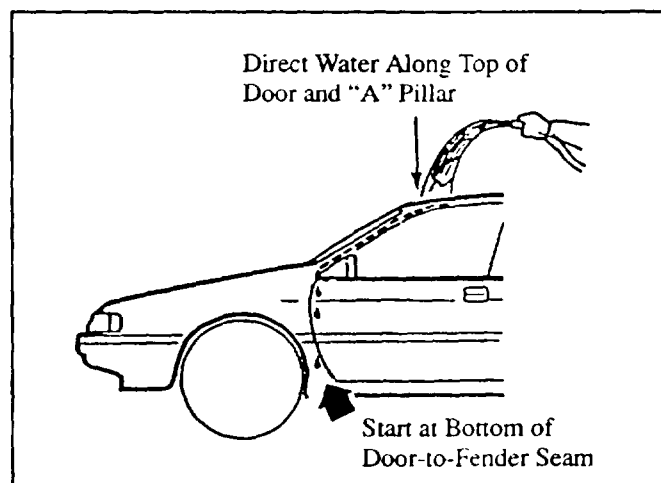
**Figure 11:** Locating Source of Front Water Leak

5. With the door closed, watch for water leaks during the hose test. Have an assistant slowly direct the water stream up from the bottom portion of the door-to-fender seam then up the "A" pillar to the top of the door and around the windshield. Next, have the assistant slowly direct water along the window beltline molding (if the vehicle is a four door, perform this test on both the front and rear doors.) **Figures 10 and 11.**

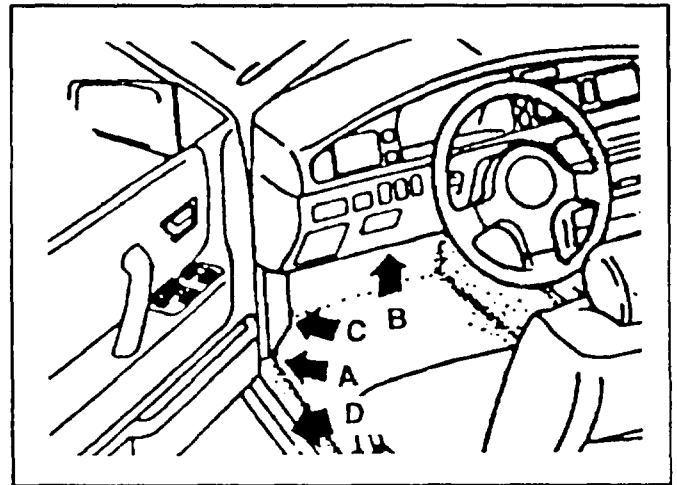
**Figure 12: Possible Water Leak Areas**

6. Note which area the water enters the vehicle. Refer to the appropriate location's repair procedure. **Figure 12.**

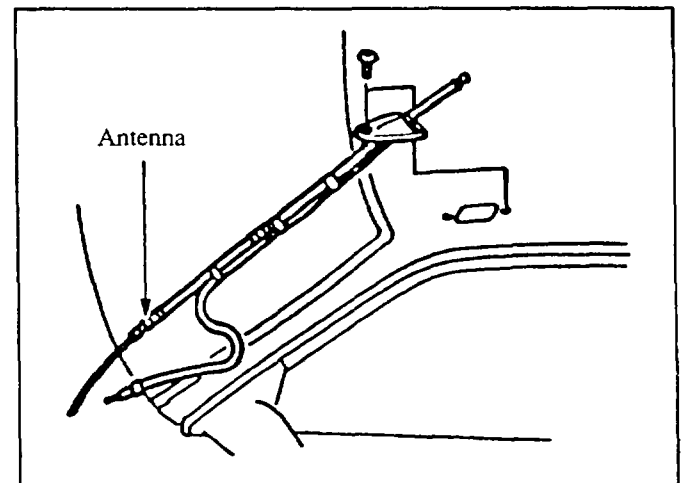
**Figure 13: Inspecting Antenna Bezel**

1. Follow the same repair procedure described for the right front side of the passenger compartment.
2. Run water on the antenna. Make sure the antenna tube is intact on the bottom of the power antenna motor and water drains properly (for models equipped with power antenna.)
3. If necessary, position the hose so there are no loops, kinks or pinched areas. If the hose cannot be corrected or is out, remove the damaged section of hose. Install a replacement piece of hose (4.7 mm [3/16 in.] outside diameter) which provides a tight fit to the existing hose.
4. If the leak persists, inspect the antenna bezel molding and gasket for correct sealing and mounting. Confirm that the mounting screw is fully seated and that the gasket is firmly contacting the roof sheet metal. **Figure 13.**

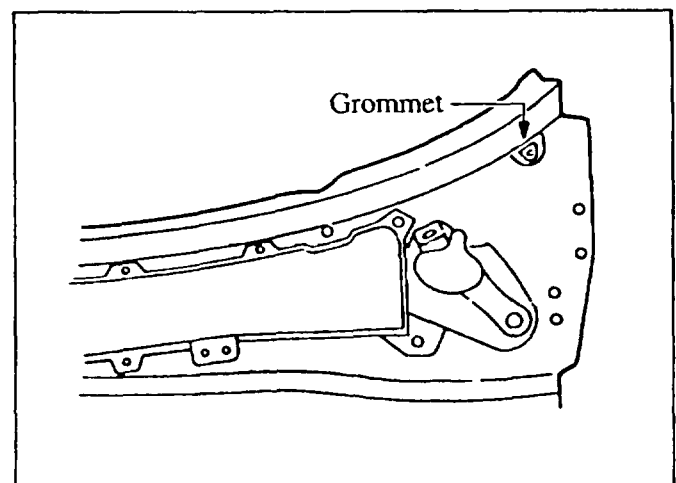
**Figure 14: Left Side Grommet**

1. Using a mechanic's mirror, look for signs of water leakage under the dash.
2. Check the cowl grommet for leaks by spraying water on it. Replace the grommet if it leaks. Apply sealer to the bottom side of the grommet during installation. **Figure 14.**

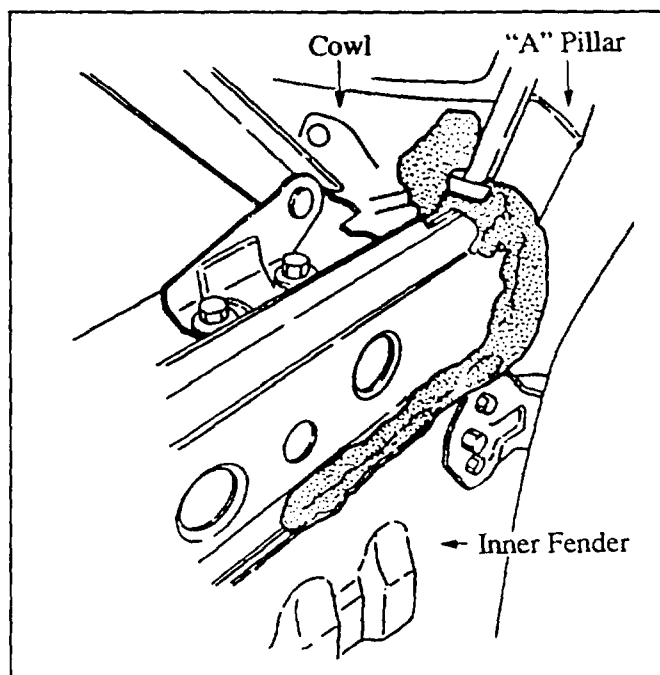
**Figure 15:** View of Adequate Body Sealer

1. Lift carpet and pad and feel for water. If water is present, remove windshield wipers and cowl plate. Check for missing sealer or holes along the lower "A" pillar-to-cowl seam. Apply sealer to any suspected areas. **Figure 15.**

2. Remove the door jamb nut and bolt, also remove the four (4) upper fender bolts. Using a mechanic's mirror, inspect sealer hidden by the upper fender for skips and pinholes. **Figure 15.**

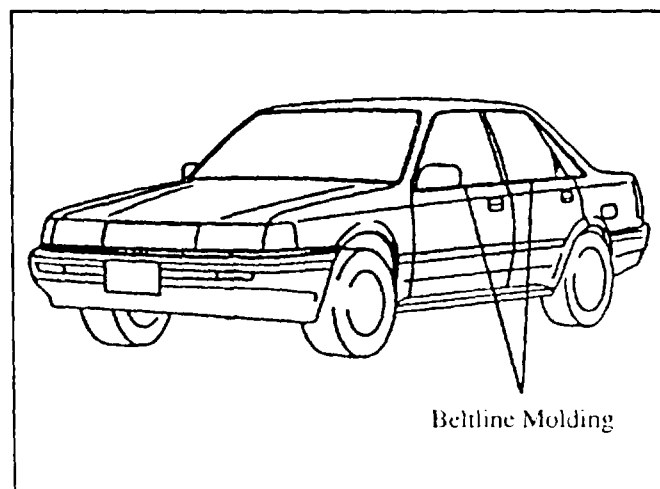
**Figure 16:** Area of Beltline Molding

1. While an assistant directs water along the beltline molding, inspect for water entering from over the plastic sill plate. **Figure 16.**
2. If water is entering over the sill plate, remove the door panel and check that the plastic sheeting Butyl sealer is pressed firmly against the door frame. Also, check that no gaps are present between the sheet metal and the plastic.

**NOTE:** If Butyl sealer is hard or non-pliable, new sealer will need to be applied to the plastic sheeting to properly seal water leaking from these areas.

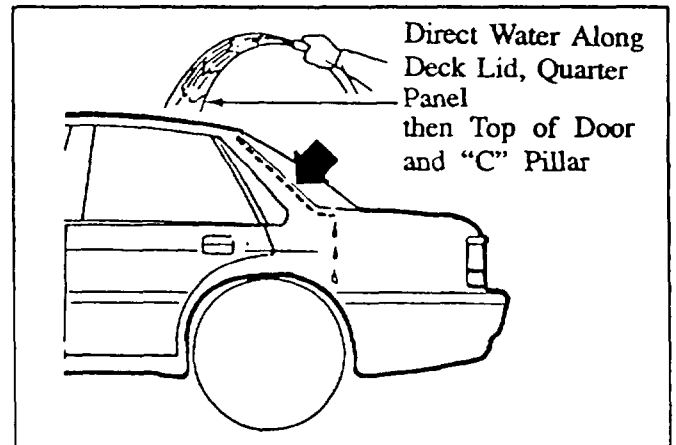
**Figure 17: Locating Source of Rear Water Leak**

4. Lower the rear seat backs. From inside the vehicle, close the door and, using a flashlight, look for water leaks during the hose test.
5. Have an assistant direct the water stream over the entire rear of the vehicle, concentrating on the following areas: **Figure 17.**

**NOTE:** Direct a heavy stream of water where the rocker panel meets the inner wheel well (to check for leakage into the rocker panel). **Figure 17.**

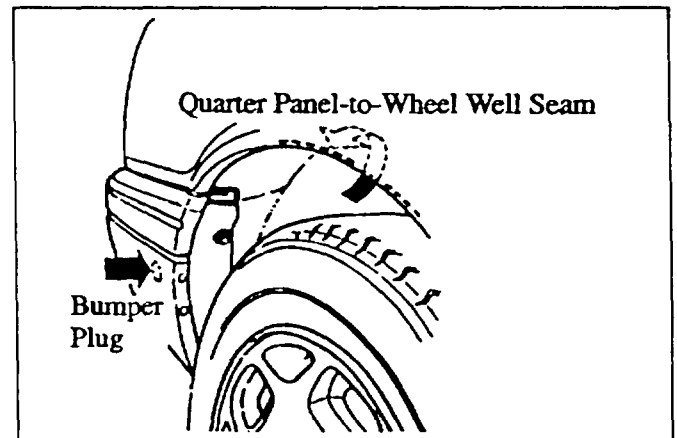
**Figure 18: Bumper Plug and Wheel Test Area**

- Inner wheel well-to-quarter panel seam and bumper plug. **Figure 18.**
  - Inner wheel well-to-trunk floor pan seam. **Figure 19.**
  - Inner wheel well-to-floor pan seam (to check for leakage under the rear seat.)

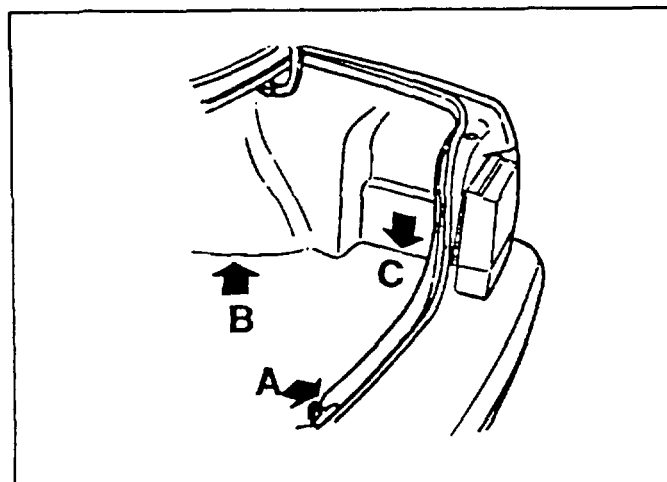
**Figure 20: Locating Possible Water Leak Areas**

7. Note which area the water enters the vehicle. Refer to the appropriate location's repair procedure. **Figure 20.**

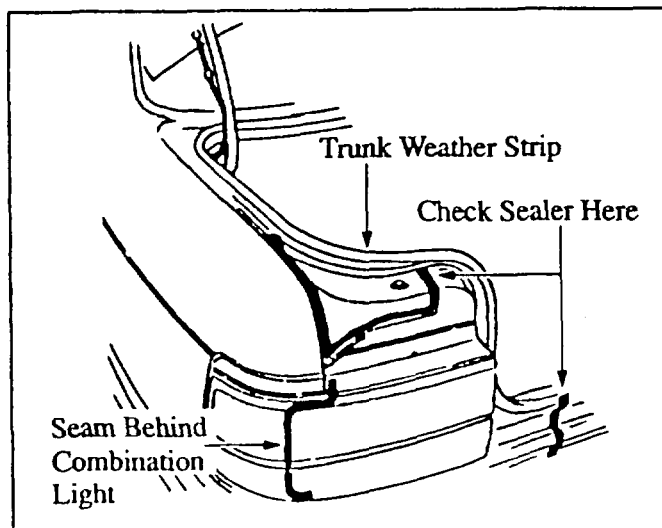
**Figure 21: Inspecting Rear Trunk Area**

1. If water is running down over the interior trunk end-panel trim or over/under the trunk weatherstrip, pull up the trunk weatherstrip and check grey sealer material and any body seams near the linkage area. Confirm that grey sealer covers the top of the flange in one solid strip. Check for pinholes, missing sealer or burrs.

2. If water is located behind the interior trunk end-panel trim or carpet, remove the trim panel. Direct a stream of water at the rear of the vehicle and pinpoint the location of the leak. Check the body seams for any pinholes or missing sealer. **Figure 21.**

4. If the leak is from the combination lamp(s) area, confirm that the mounting studs/nuts are tight and the assemblies are not cracked. Check end panel-to-quarter panel seams for any pinholes or missing sealer. If the leak continues, remove the combination lamp(s) and gasket(s). Install a new gasket to the combination lamp(s). **Figure 21.**

3. If pinholes and/or missing sealer are found in step 2, add a non-hardening grey body seam sealer to fill in the empty spots and reinstall the trunk weatherstrip. Make sure the trunk weatherstrip is routed under the latch striker and press it firmly in place. Retest for water leaks.

**NOTE:** Before installing the new gasket, apply sealer to both sides of the gasket. Also, confirm body-to-combination lamp surfaces are flush and no burrs are present.

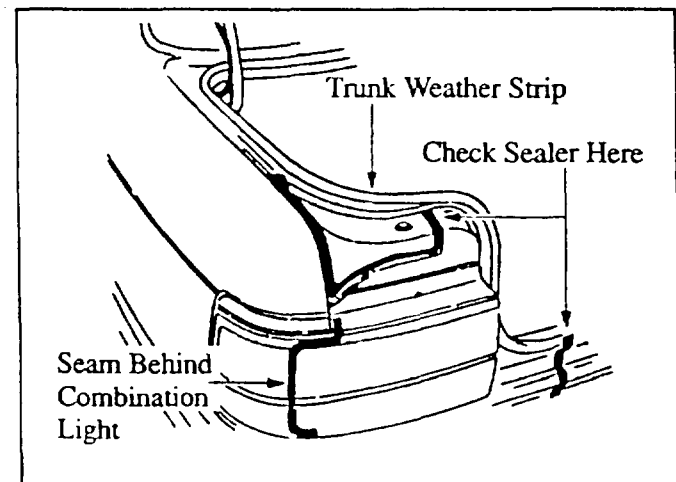
**Figure 23:** Inspecting Rear Trunk Area

1. If water leaks into the forward area of the trunk, make sure that the weatherstrip is properly seated and not leaking. **Figure 23.**
2. If no problems are found, check all trunk opening seams and the inner wheel well-to-trunk floor pan seam for missing sealer or pin holes. Seal any suspected areas and retest for leaks. If no problems are found, go to step 3.

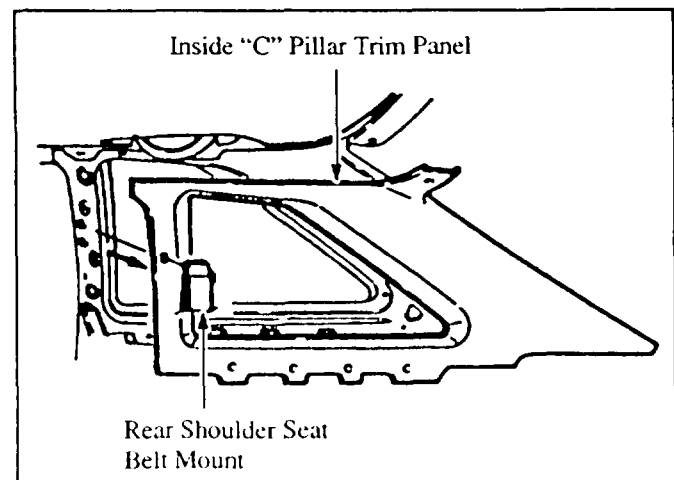
**Figure 24:** Removing Inside "C" Pillar Trim Panel

3. If necessary, remove the rear shoulder seat belt mounts and inside "C" pillar trim panel(s). Remove the mounting nuts. Next, remove the rear window glass side molding. **Figures 24 and 25.**

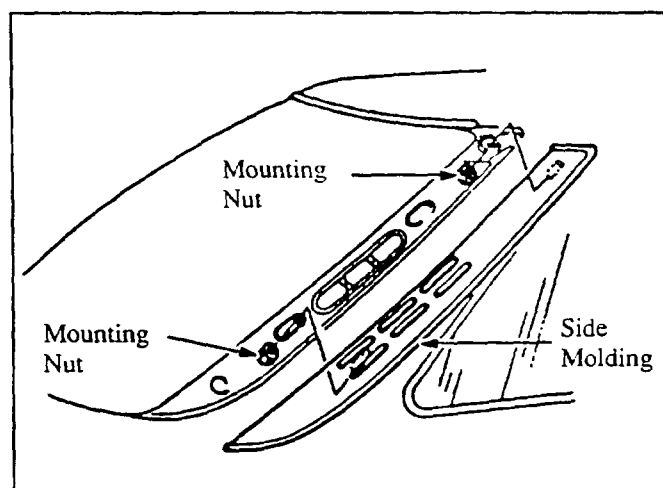
**Figure 25: Removing Rear Window Glass Side Molding****AREA C: STORAGE WELLS (RIGHT OR LEFT) BEHIND WHEEL WELL**

4. Check the condition of the rear window sealer in this area. Use a flashlight to find small pinholes. Check extractor side molding mounting hardware for missing or damaged sealer or gaskets. Apply sealer to all mounting points as necessary. **Figure 25.**

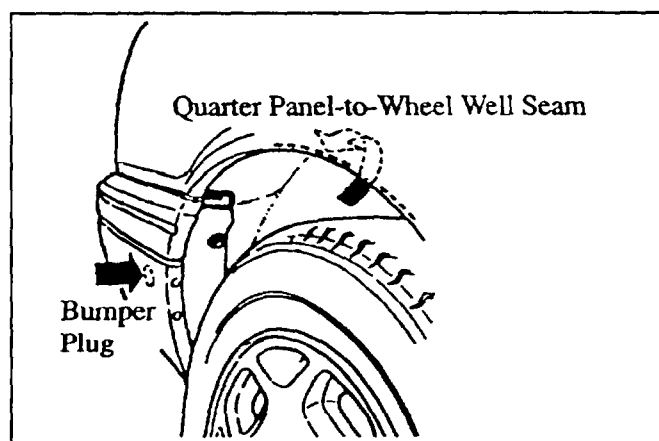
**Figure 26: Bumper Plug and Wheel Test Area****AREA D: INNER WHEEL WELL-TO-FLOOR PAN (UNDER REAR SEAT) AND INSIDE THE ROCKER PANELS**

2. Check for any leaks at the grommet and plug between the quarter panel and bumper. Examine seams for missing sealer or pin holes. Seal any suspected defects. **Figures 26 and 27.**
3. Check for any leaks at the fuel filler neck-to-body in the left quarter. If moisture is present, remove the filler neck.
4. Apply sealer to both sides of the gasket and reinstall.

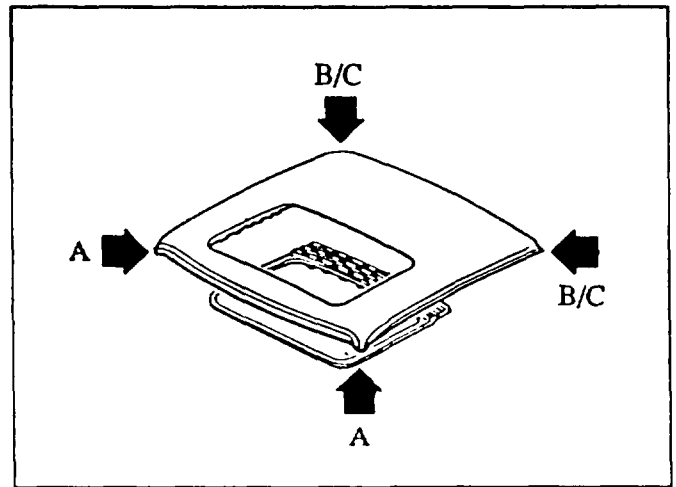
**Figure 28: Locating Source of Top Water Leaks**

1. Have an assistant help locate the exact point of water entry.
2. Turn the water pressure to the hose so that a 12" to 18" stream of water is present while the hose is in a vertical position.
3. Make sure the sunroof is completely closed.  
If necessary, readjust sunroof.  
(See Workshop Manual Section S.)
4. Run water over the sunroof and note in which area the water enters the vehicle. Refer to the appropriate location's repair procedure. **Figure 28.**

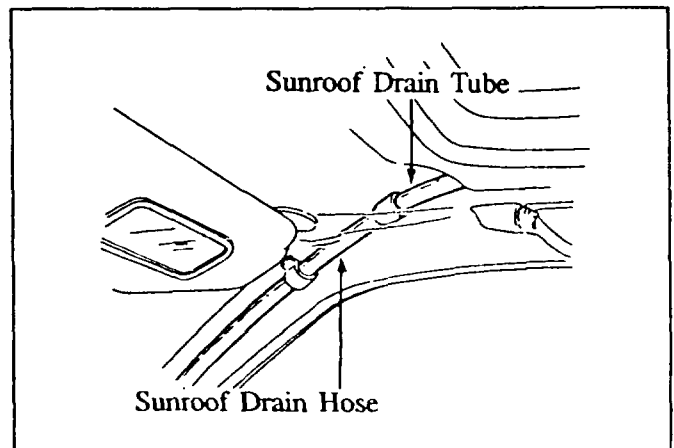
**Figure 29: Checking Front Drain Hose and Tube**

1. Open the sunroof and make sure that the sunroof drain tubes are intact and that no holes are present. If welds are damaged or have holes, repair or replace the sunroof frame.
2. If welds and drain tubes are OK, remove the front header and side trim pieces. Remove the headliner retainer clips (2 metal and 1 plastic per side), sunroof welt, and sun visor.
3. Carefully lower the headliner. Using a flashlight, check that the drain hose tubes are attached to the sunroof frame. **Figure 29.**
4. Direct a small stream of water into sunroof drain holes to make sure the drain tubes do not leak. If leaking is present, check for damaged hoses.
5. If the hoses are damaged, install a replacement piece of hose which provides a tight fit to the existing hose. The outside diameter of the replacement hose should be 9.5mm (3/8 in).

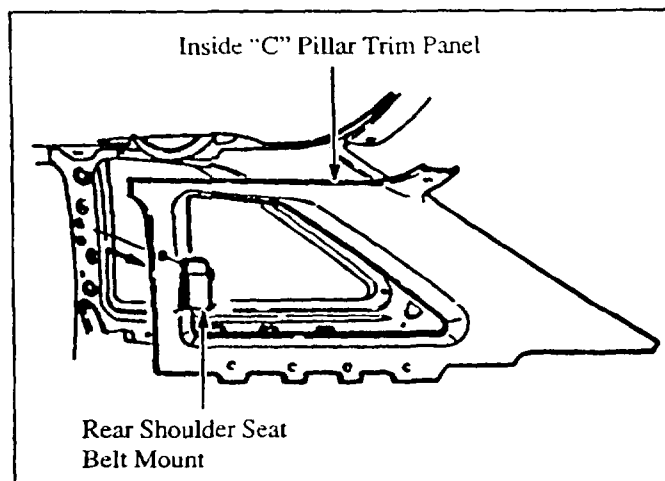
**Figure 30:** Removing Inside "C" Pillar Trim Panel

1. Remove rear header trim, rear shoulder mounts, and inside "C" pillar trim panel(s). **Figure 30.**

1. Remove the rear header trim, rear shoulder seat-belt mounts, and inside "C" pillar trim panel(s). **Figure 30.**

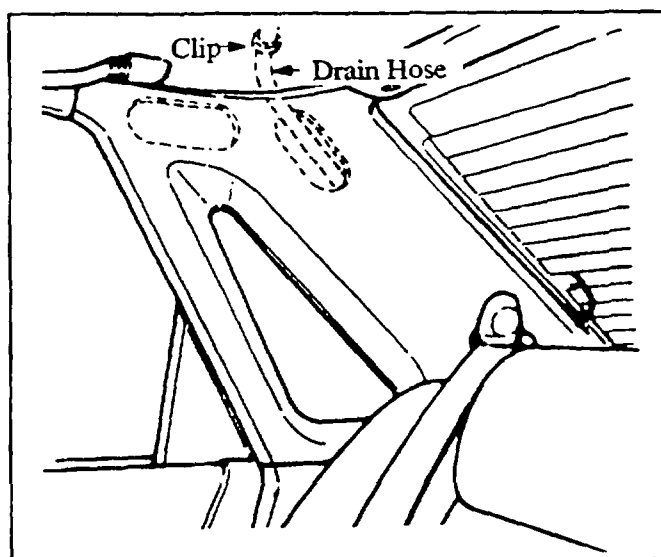
**Figure 31:** Rear Sunroof Drain Hose

4. Check that the drain hoses are attached to the sunroof drain tubes. Replace hose(s) as necessary. Check for kinks at the drain hose clip. **Figure 31.**
