Service Bulletin

Category 7	Applicable Model/s '87-'89 626/MX-6 Turbo & Non-Turbo	Subject EC-AT REBUILD PROGRAM	Bulletin No. 065/89 Issued 9/27/89 Revised
---------------	---	----------------------------------	--

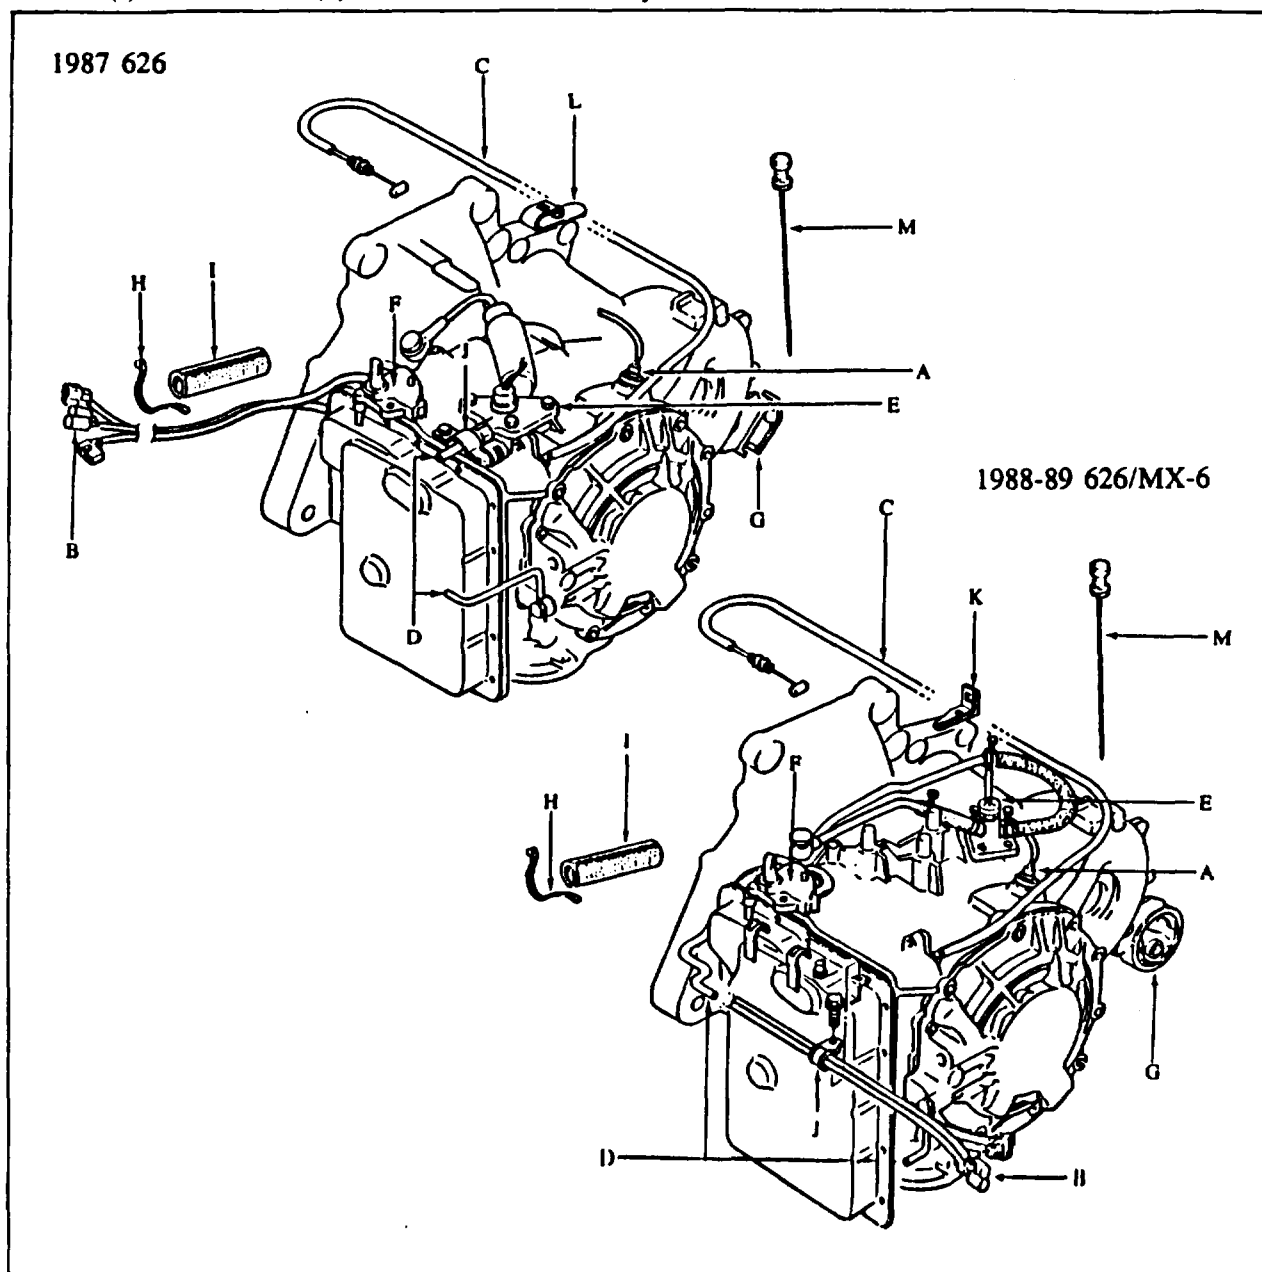
For your convenience, the illustration below shows items which should be reinstalled on the rebuilt transmission (-) and returned (x) with the failed assembly.

1987 626	1988-89 626/MX-6
A) Pulse Generator	x	x
B) Cord	x	x
C) Throttle Cable	x	x
D) Oil Pipes	x	x
E) Thermo Switch Box	x	x
F) Inhibitor Switch	x	x
G) Engine Mounting Rubber No.1	x	x
H) Bands (for Cord)	x	x
I) Protector (for Cord)	x	x
J) Clip (for Cord)	x	x
K) Throttle Cable Bracket	-	x
L) Throttle Cable Clip	x	-
M) Oil Level Gauge	x	-
