Service Bulletin

MAZDA

Category B	Applicable Model/s 1988-'90 626/MX-6	Subject HYDRAULIC LASH ADJUSTER (HLA) NOISE	Bulletin No. 004/90 Issued 6/8/90 Revised
---------------	--	--	---

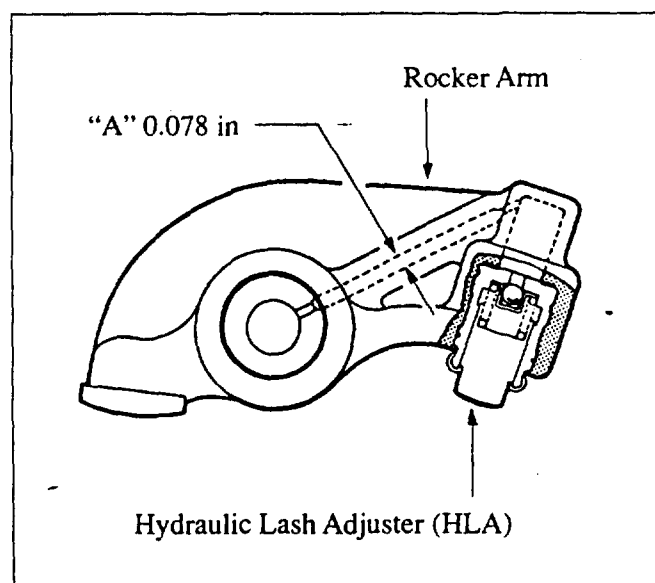
If you encounter a complaint of HLA noise when returning to an idle after freeway driving that continues for approximately one minute, the rocker arms may need to be replaced.

As illustrated, the diameter of the oil passage "A" on the modified rocker arm has been enlarged (0.031 in to 0.078 in). With this modification, oil volume to the HLA increases and the period of HLA noise is reduced.

- 1) When removed from the rocker arm shaft, inspect the contact area of the rocker arm. If it is scratched, replace the rocker arm shaft. Otherwise, due to oil pressure, leakage may result.
- 2) Please instruct customers to observe scheduled maintenance intervals. Inadequate amounts of oil or oil deterioration may cause the problem to reoccur.
