# Service Bulletin

Category S	Applicable Model/s 1988-92 626	Subject WATER ENTERING TRUNK AND/OR COMBINATION LAMP ASSEMBLY	Bulletin No. 017/94 Issued 4/5/94 Revised
---------------	-----------------------------------	---	---

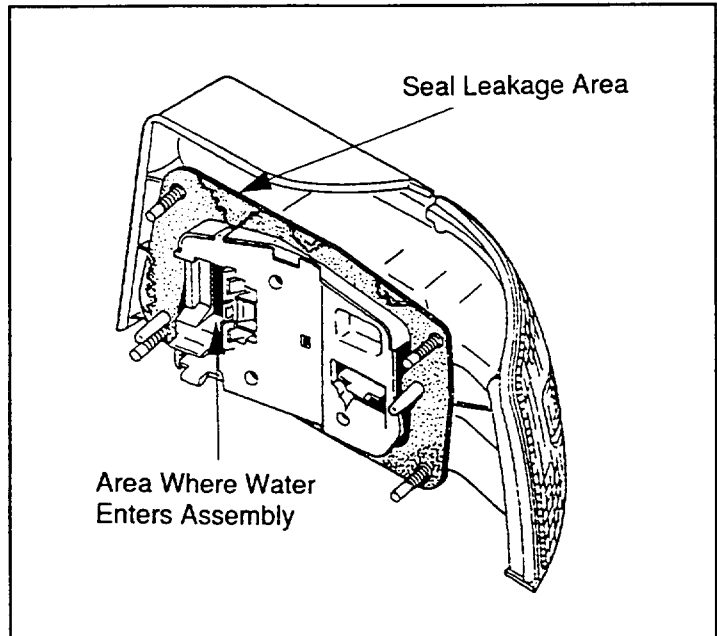
Tail lights that fail due to water entering the combination lamp assembly are caused by leaks in the gasket and not the combination lamp assembly. Recent studies show that assemblies are being replaced unnecessarily.

1. Verify complaint.
2. Remove water from the trunk area with a shop vacuum.
3. Check the trunk weather-strip for damage and proper positioning.
4. Remove the rear combination lamp and inspect the body to lamp assembly seal. Refer to the illustration for signs of water leakage.
5. If the lamp seal is leaking, replace the seal and confirm that the installation studs are tight and no cracks exist in the assembly.
6. Install the lamp assembly with a new seal.

**NOTE:** Prior to installing the lamp assembly, apply sealant to both sides of the seal and confirm that the seal to lamp assembly is flush and no burrs are present.
