Service Bulletin

Category K*	Applicable Model/s 1988-89 626/MX-6 Turbo	Subject D1-D2 SHIFT SHOCK	Bulletin No. 003/90 Issued 4/20/90 Revised
----------------	---	----------------------------------	--

DESCRIPTION

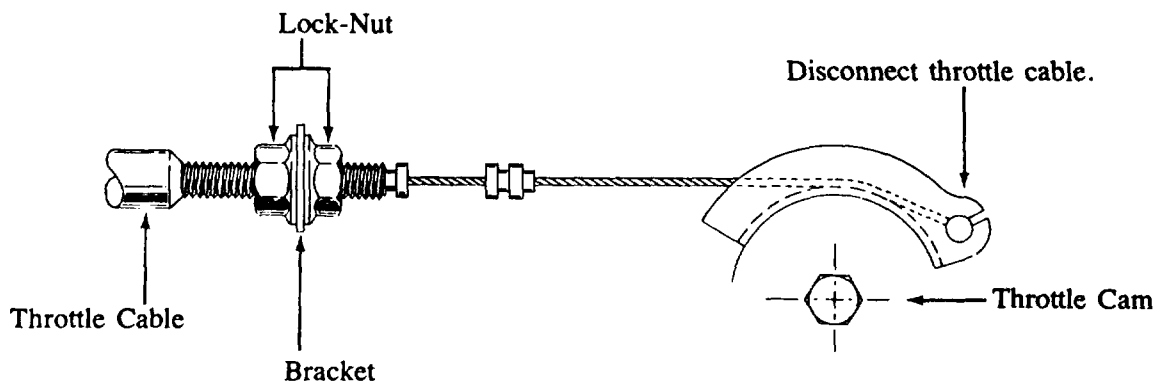
3. Verify that the throttle cable is free of "slack" in accordance with the following procedure.
 - a) Read the line pressure (a) indicated on the pressure gauge (P/N 49B0 19 901).
 - b) Disconnect the throttle cable from the throttle cam and read the line pressure (b).

- If the value of the line pressure (a) is higher than (b), the result is OK.
- If the line pressure does not change, go back to step 2 and readjust the throttle cable.

When the throttle cable has "slack", the line pressure does not increase in proportion to the engine torque, causing D1 to D2 shift shock.

If the line pressure is out of the specification, adjust the line pressure by adjusting the lock nuts of the throttle cable.
