# Service Bulletin

Category S	Applicable Model/s 1988-'91 626/MX-6	Subject POWER DOOR LOCKS MALFUNCTION	Bulletin No. 018/91 Issued 11/22/91 Revised
---------------	--	---	---

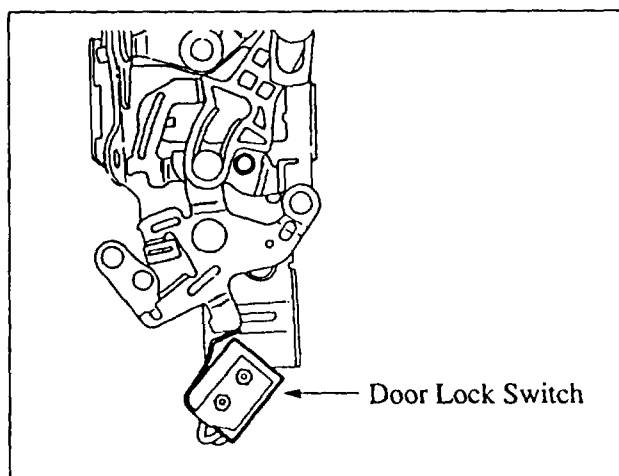
**Figure 1: Power Door Lock Switch  
(Driver's Door)**

A driver's side door lock that does not lock or unlock the remaining doors may have a damaged circuit in the door lock switch.

1. Inspect switch. See Section 14 or S of the Workshop Manual.
2. If necessary, replace the driver's door lock switch. See Workshop Manual for replacement procedures. **Figure 1.**
