Service Bulletin

Category N	Applicable Models 1988-92 626/MX-6	Subject RATTLING NOISE FROM THE POWER STEERING RESERVOIR	Bulletin No. 003/93 Issued 11/5/93 Revised
---------------	---------------------------------------	--	--

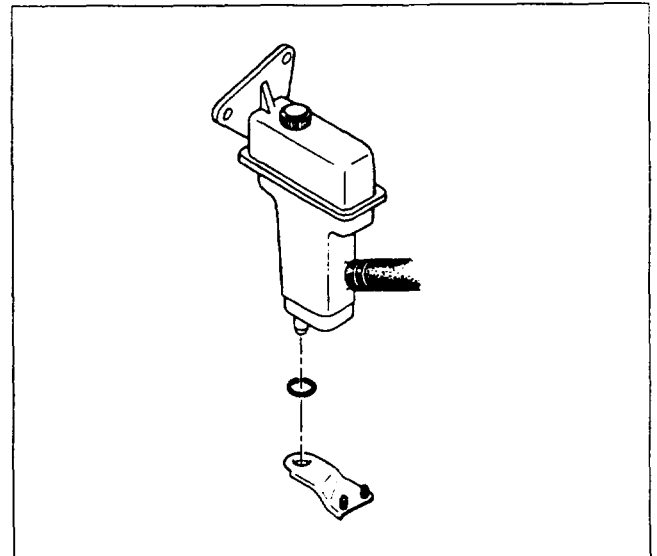
A rattling noise heard from the front passenger side of the vehicle may be caused by the power steering reservoir mounting pin and the lower mounting bracket locator hole. The noise is difficult to duplicate and is most evident during cold engine starts.

1. Verify that the complaint is not coming from another part of the vehicle.
2. Remove the 2 mounting bolts from the bottom of the power steering reservoir.
3. Lift the reservoir to access the lower mounting bracket.
NOTE: When raising the reservoir, take care not to spill the power steering fluid on painted surfaces. If fluid does spill, clean up immediately.
4. Insert grommet into the locator hole in the lower mounting bracket.
5. Lubricate the grommet to facilitate installation of the locator pin on the reservoir.
6. Install the two mounting bracket bolts.
