Service Bulletin

Category B	Applicable Model/s 1988-90 626/MX-6 ATX	Subject IDLE VIBRATION IN "D" RANGE	Bulletin No. 001/90 Issued 4/20/90 Revised
---------------	---	--	--

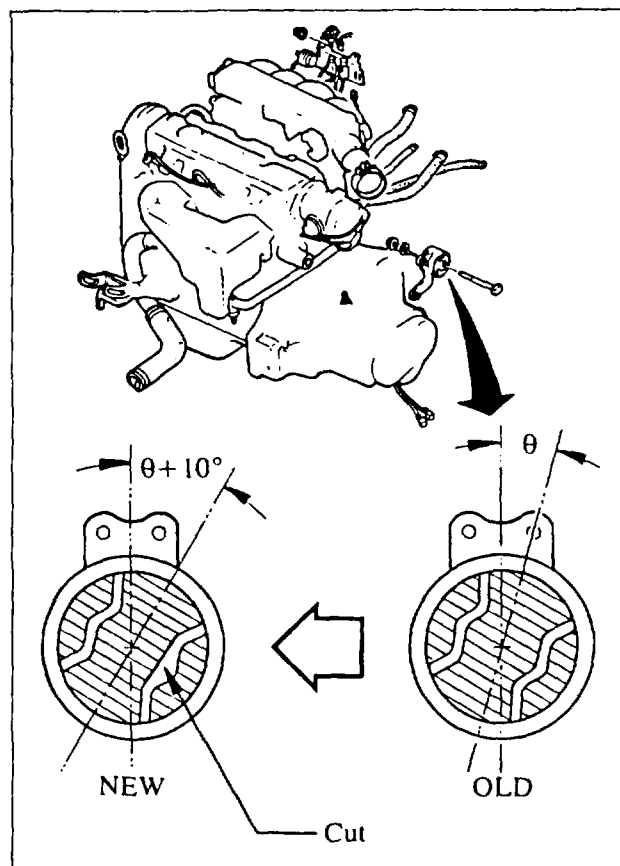
No. 1 engine mount and radiator lower mount rubbers have been changed as follows:

• No. 1 Engine Mount

- The diameter of the rubber has been increased from 3.15 in. to 3.54 in. since the November, 1988 production.
- The rubber has been turned 10° toward the engine side since the November, 1988 production.

• Radiator Lower Mount

- Changed since June, 1989 production.
