Service Bulletin

Category S	Applicable Model/s 1988-'91 626	Subject PASSIVE SHOULDER BELT DOOR SWITCH HARNESS MODIFICATION	Bulletin No. 013/91 Issued 8/8/91 Revised
---------------	------------------------------------	--	---

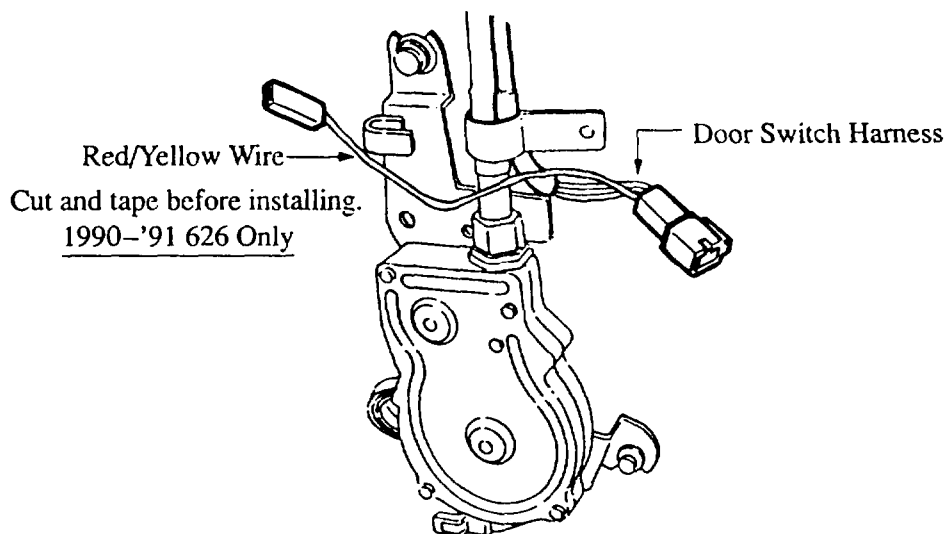
Figure 1: Door Switch Harness Wire Location

Replacement passive shoulder belt assemblies have a red/yellow wire from the limit switch connector. This wire plugs into the door catch connector on 1988 and '89 626 models.

Red/yellow wire applies to 1988 and 1989 626 models only.

There is no car-side harness plug for this wire on 1990 and '91 626 models. When replacing this assembly on 1990 and '91 626's, cut the wire and tape it to prevent short circuits from occurring. **Figure 1.**
