Service Bulletin

Category U	Applicable Model/s 1988-89 626/MX-6	Subject CONTINUOUS A/C COMPRESSOR ENGAGEMENT	Bulletin No. 002/90 Issued 4/23/90 Revised
---------------	---	--	--

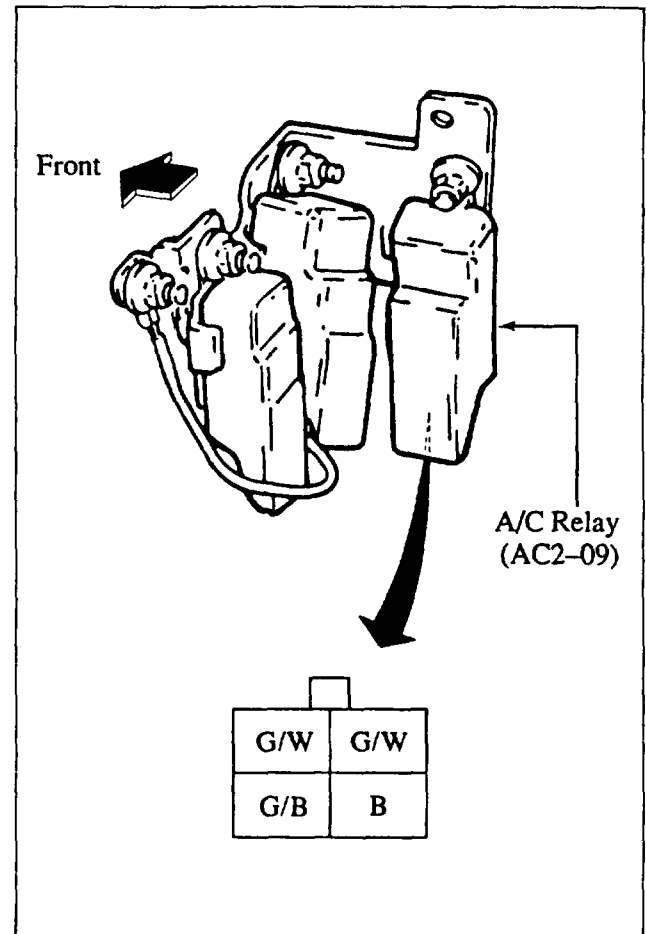
The A/C relay (AC2-09) is located below the right headlamp. There are three relays in one place. Locate the A/C relay by referring to the wire colors illustrated.

If the "1F" voltage was incorrect, the E.C.U. has an internal failure. Replace the E.C.U. and the A/C relay (AC2-09).

Since the E.C.U. has not been modified, the A/C relay (AC2-09) should be replaced with a new, resistance-type relay. Used in the 1990 626/MX-6 models, the resistance-type relay prevents the surge current from flowing into the control unit.
