MazdaTips

Mazda Motor of America, Inc. (MMA)
Customer Support Division

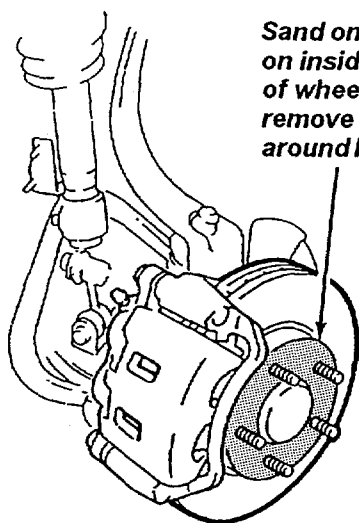
You probably don't need to replace any parts if a customer complains the vehicle's front wheels make a clicking sound. Often, several clicks can be heard from the outside wheel during a slow turn.

Sand on this surface and on inside mounting surface of wheel. You don't need to remove brake rotor (sand around bolts).

We featured this concern in the June issue of *Mazda Tips* and the fix still applies: remove the wheel, then use coarse sandpaper to clean the disc plate's contact area and the wheel mounting surface (see illustration). Carefully remove the abrasive dust produced from sanding and re-install the wheel. Tighten lug nuts to a maximum torque of 94 ft. lbs.

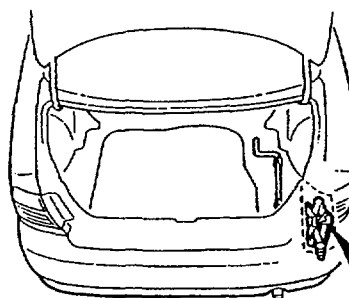
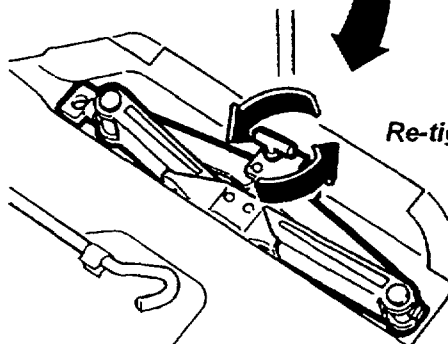
The spare tire jack wing bolt may be too tight. During PDI, make sure you can loosen the bolt by hand. If you can't, loosen it with a suitable tool and re-tighten it by hand until it is finger tight. Then, tighten it another eighth of a turn by hand.

Re-tighten by hand

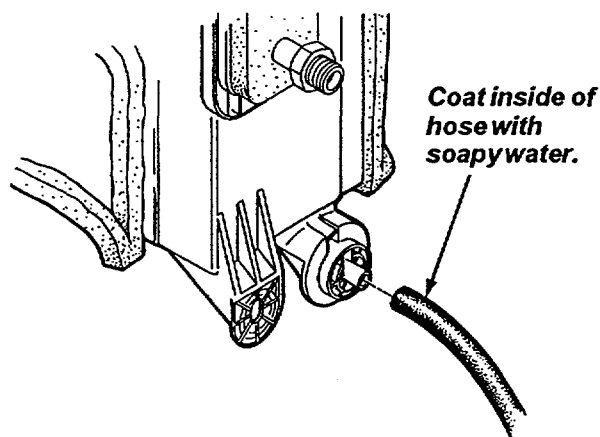
Water from the air conditioning evaporator case could leak onto the front passenger's side carpet because the case's drain hose may fall off.

Before you attach the end of the hose onto the case, coat the first 40 mm of the inside of it with soapy water. This will create a bond with the case's spout that is sticky enough to prevent the hose from falling off again.

Be sure to re-insert the hose completely and check that the other end is routed through the firewall grommet.

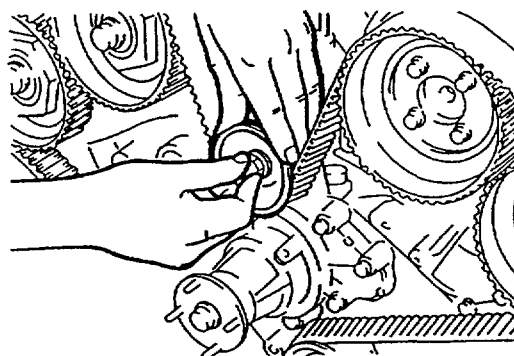
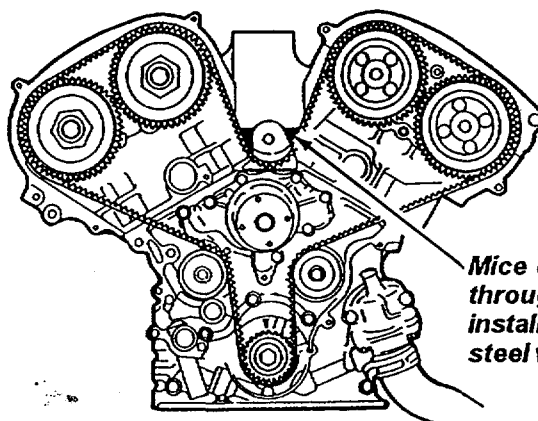
The engine may have a rough idle, lose power below 4500 rpm or stall, but it doesn't misfire and there are no codes. Your next step? See if the

timing belt has jumped one or more teeth.

Mice may cause the belt to jump teeth. In cold climates especially, they can crawl through a gap between the two cylinder heads and possibly build a nest on the belt. When the engine starts up, this interference may force the belt off track.

Remove No. 2 Idler Pulley to see gap.

If you discover this condition, you can prevent it by cleaning and re-setting the belt, then putting stainless steel wool in the gap. You must remove the No. 2 Idler Pulley to get to the gap (see WSM pages B12 to B15). Don't use plain steel wool because it will rust.

Next, clean the engine surfaces around the wool and apply high-temperature silicone around it. This will form a seal to the surface and reinforce the blockage.

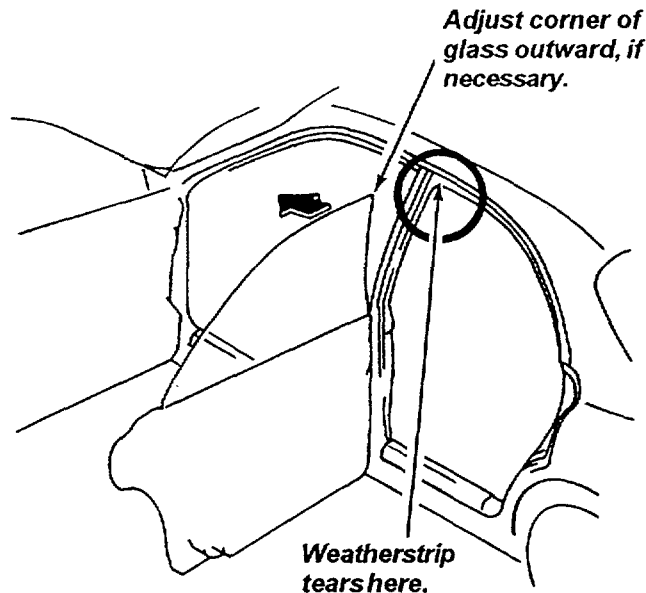
A torn weatherstrip at the rear door's upper front corner may cause wind or water leaks. In

time, the weatherstrip could tear if a slightly misaligned door glass digs into it when the door is closed.

If the weatherstrip is torn, install a new one, but ensure the door glass is properly adjusted. If the glass is set too far inward, adjust the corner slightly outward, according to the Workshop Manual procedure (page S-22). Be careful not to adjust it too far outward or you'll create another wind or water leak.

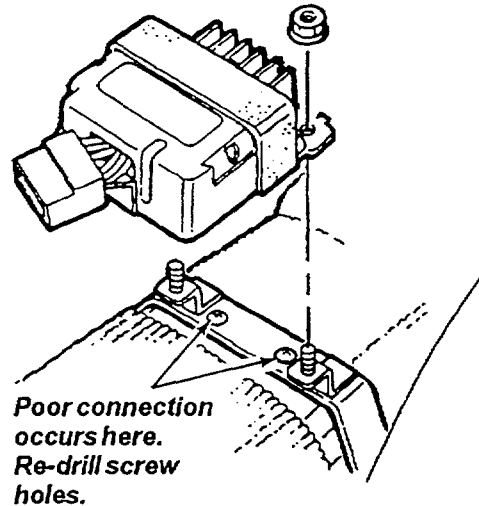
On some '94 vehicles, the front center speaker may work intermittently because of a poor ground connection at the speaker's amplifier mounting bracket. The amplifier is located

behind the gear shift lever.

The poor connection results from stripped screw holes on the bracket. Redrill the screw holes and use either larger machine screws or rivets. You might also consider installing a separate ground wire to the vehicle body.

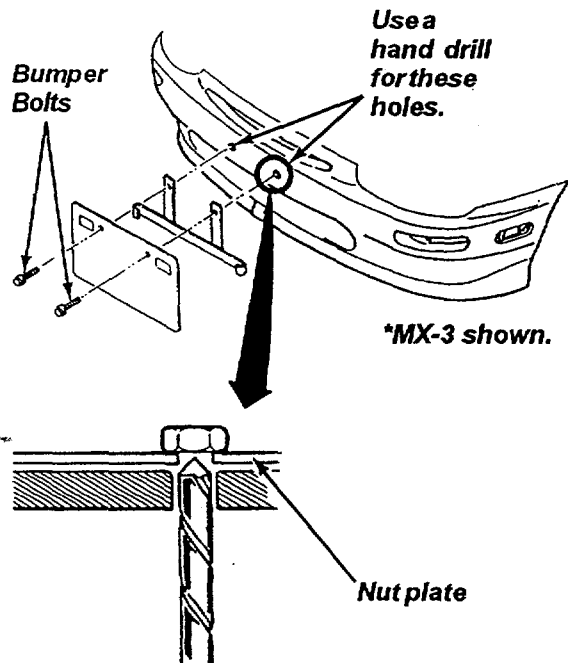
When you drill the holes to install the license plate frame, do it by hand. If you use a power drill, the nut plate attached to the inside of the bumper could come off.

The nuts on this plate anchor the bumper bolts you use to install the license plate frame. And if the nut plate comes off, you must remove the bumper to repair it.

If you don't have a hand drill, you can turn a power drill by hand.
