# Service Bulletin

Category U	Applicable Model/s 1988-'90 626/MX-6 w/ A/C	Subject REFRIGERANT LEAK FROM INLET/OUTLET PIPE OF RECEIVER/DRIER TANK	Bulletin No. 008/90 Issued 12/19/90 Revised
---------------	---	--	---

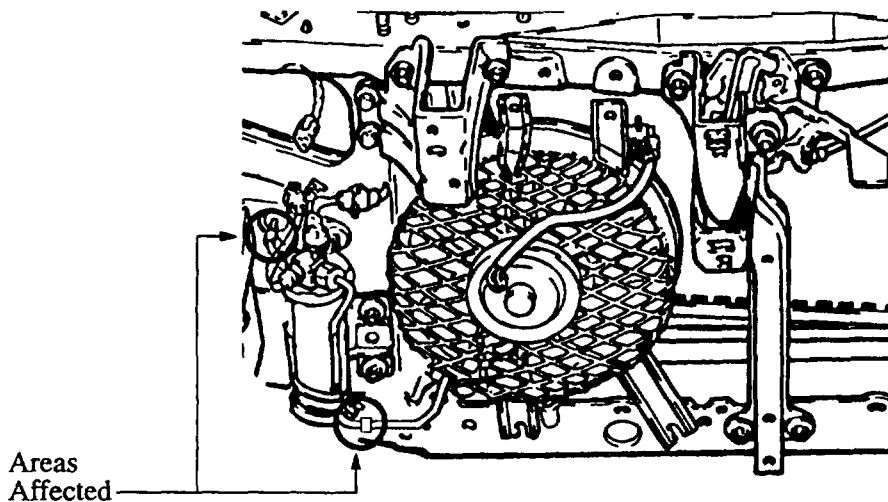
It has been found that the inlet or outlet pipe of the receiver/drier tank may develop a pinhole at the area shown below where the pipes are held by small steel clips. This may result in a refrigerant leak.

Galvanic corrosion occurs between the aluminum pipe and the steel clip. This condition is more likely to develop in geographic areas that use large amounts of salt on the roads and highways.

- If a refrigerant leak is suspected, inspect the pipes of the receiver/drier tank.
- The inlet/outlet pipes are available as a service part. Refer to the parts information in this bulletin.
- In order to prevent galvanic corrosion from recurrence, place vinyl tape (insulator tape) between the steel clip and the aluminum pipe.
