Service Bulletin

Category D	Applicable Model/s Various Models	Subject OIL PRESSURE SWITCH LEAKAGE ENGINE OIL LIGHT ILLUMINATION	Bulletin No. 003/96 Issued 09/23/96 Revised
---------------	--------------------------------------	---	---

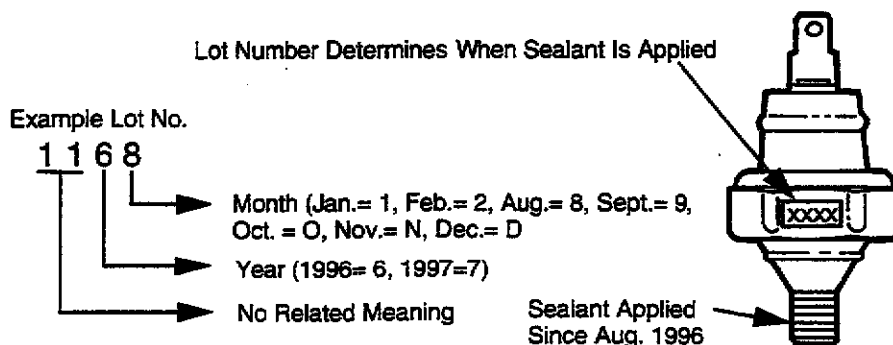
Engine oil may leak from the oil pressure switch causing the engine oil light to illuminate. The type of switch has been changed to reduce this concern.

1. Verify the complaint.
 - If the oil pressure switch is leaking, proceed to step 2.
 - If the switch is not leaking (and the light illuminating), refer to the section D of the workshop manual for diagnostic and repair information.
2. Replace the oil pressure switch with a new part (refer to Parts Information).
 - Apply the sealant (listed below) to the threads and install the switch.
Three Bond: TB1207D or Loctite: Ultra Black 598 (or equivalent)
3. Verify repair.
