Service Bulletin

Category 4	Applicable Model/s 1988-89 626/MX-6 (w/o Turbo)	Subject IDLE SPEED FLUCTUATION OR HUNTING	Bulletin No. 056/89 Issued 4/24/89 Revised 6/30/89
---------------	---	--	--

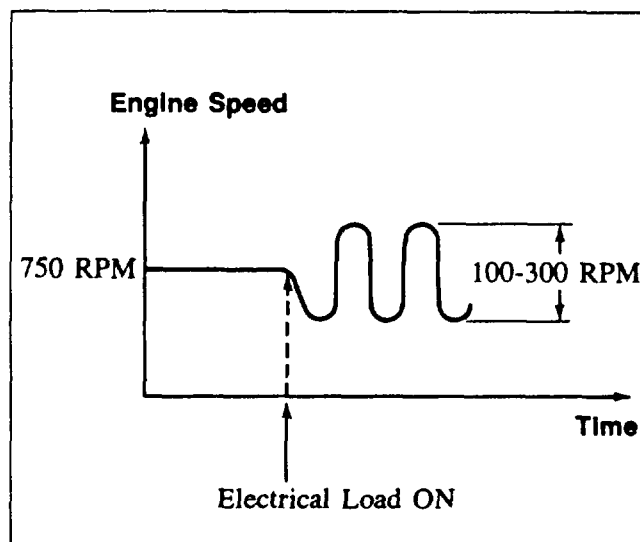
Idle speed fluctuation or hunting may occur when the electrical load such as headlights, rear defroster and so on are turned on while idling. This condition likely occurs easily if the idle speed is adjusted too low.

2. With the test connector NOT grounded, check for a fluctuation in the idle when the head lights and rear defroster are turned "ON". If fluctuation is present, ground the test connector and adjust the idle speed to 950 – 1000 RPM (in neutral with the parking brake applied).*
