Service Bulletin

Category S	Applicable Model/s 1988-'91 626/MX-6	Subject WIND NOISE	Bulletin No. 036/92 Issued 7/7/92 Revised
---------------	--	---------------------------	---

DESCRIPTION

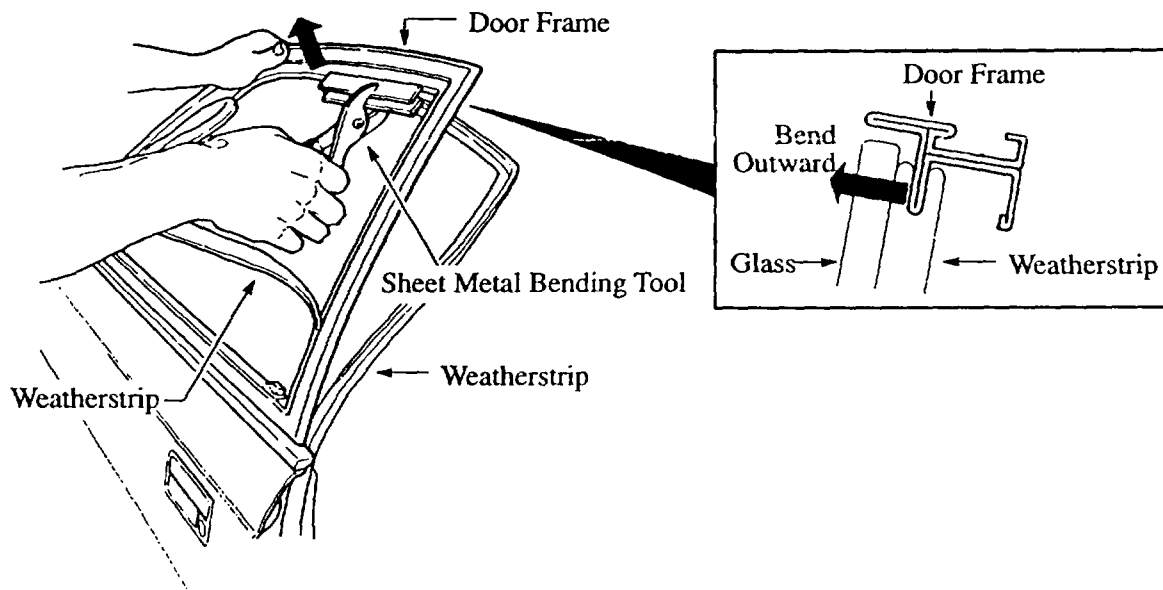
Condition D: Door Glass Drop

1. Use a business card as you would a feeler gauge to check for looseness (gaps) between the door glass and weatherstrip. The weatherstrip should press firmly against the glass around the entire door frame. Areas that do not form a tight seal between the glass and weatherstrip may allow the glass to drop thereby causing air leaks.
2. With the window in the down position, remove the following parts according to Workshop Manual procedures section S:
 - a) Black Plastic Inner Sail Garnish
 - b) Window Frame Weatherstrip
3. Remove the weatherstrip to access the glass run channel frame.
4. Carefully bend the weatherstrip frame slightly outward ($1/16''$) to increase the pressure of the weatherstrip against the glass. Use a sheet metal bending tool (Snap-on P/N VP8R or equivalent).

5. Install removed parts in the reverse order of removal.
6. Recheck the weatherstrip using the business card insertion technique.
