# Service Bulletin

Category K	Applicable Model/s 1988-90 626/MX-6 incl. Turbo	Subject EC-AT SLIPPAGE IN FORWARD GEARS	Bulletin No. 005/90 Issued 5/14/90 Revised
---------------	---	--	--

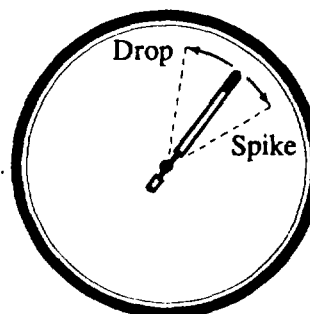
LINE PRESSURE GAUGE

- B. Next, quickly and smoothly pull the throttle cable out to one-half way of its travel (half throttle) and hold. Check for line pressure spike (maximum) and drop (minimum) readings using a line pressure gauge.

- A good oil pump should show a smooth increase of pressure and level off at a stable pressure.
    - If the spool valve of the oil pump is stuck, it may cause a pressure spike and variation in pressure before leveling off, or it may show little/no increase in pressure. (Refer to the illustrations.)

4. If a problem is found in Step 3, replace the oil pump spool valve according to the Replacement Procedure.
5. Recheck the line pressure according to Step 2 and perform the road test to confirm that the problem is fixed.
