# Service Bulletin

Category U	Applicable Model/s 1988-'90 626/MX-6 w/ A/C	Subject REFRIGERANT LEAK FROM INLET/OUTLET PIPE OF RECEIVER/DRIER TANK	Bulletin No. 008/90 Issued 12/19/90 Revised
---------------	---	--	---

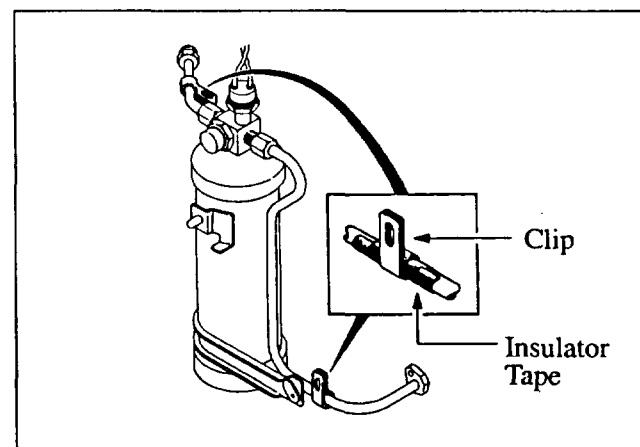
It has been found that the inlet or outlet pipe of the receiver/drier tank may develop a pinhole at the area shown below where the pipes are held by small steel clips. This may result in a refrigerant leak.

Galvanic corrosion occurs between the aluminum pipe and the steel clip. This condition is more likely to develop in geographic areas that use large amounts of salt on the roads and highways.

When replacing the pipes, place the vinyl tape (insulator tape) between the steel clip and the aluminum pipe in order to prevent galvanic corrosion from recurrence.

4. Reinstall the parts removed during step 2.
5. Evacuate and charge the system. Make sure that there is no leak and that the A/C works properly. Check the headlight and turn signal light operation. Adjust the headlight aiming, if necessary.
